SAN ONOFRE'S STEAM GENERATORS: SIGNIFICANTLY WORSE THAN ALL OTHERS NATIONWIDE

JULY 11, 2012

ARNIE GUNDERSEN, MENE
FAREWINDS ASSOCIATES
BURLINGTON, VERMONT, USA

REPORT COMMISSIONED BY FRIENDS OF THE EARTH

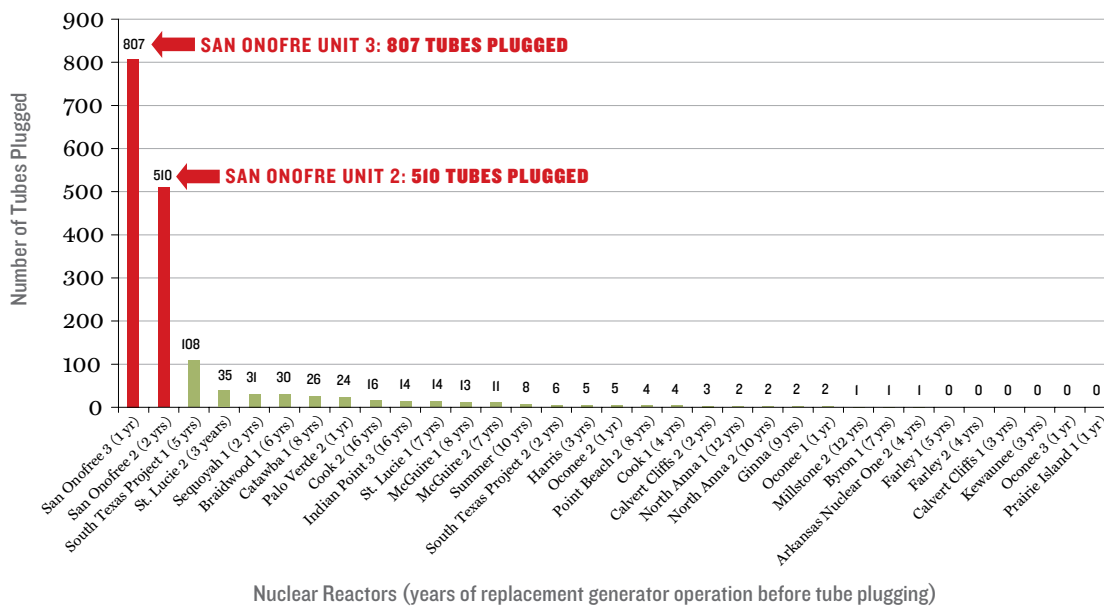
As evidenced in Figure 1, Edison has plugged 3.7 times more tubes in its San Onofre Units 2 and 3 replacement steam generators than the nationwide total of all plugs inserted in all the remaining replacement steam generators in all US nuclear reactors. Moreover, the NRC and Edison have not openly informed the public about the magnitude of tube generator plugging at San Onofre compared to the remainder of U-tube damage at other US reactors.

**U.S. Nuclear Reactors Replacement Steam Generators
Tubes Plugged to Avoid Generator Failure³**

Even a casual overview of the data presented in Figure 1 shows an alarming difference at San Onofre in comparison to other operating US nuclear reactors. The minor differences between the replacement steam generators at San Onofre Units 2 and 3 are inconsequential when those steam generators are compared to replacement steam generators at all other US nuclear power plants.

More tubes are plugged in the replacement steam generators at ***EITHER*** San Onofre Unit 2 or Unit 3 than the total number of plugged tubes at every other replacement steam generator in every nuclear plant in the US.
